## Analysis of a Leaking Hog Fuel Boiler Floor Tube

Analysis of a leaking boiler tube revealed definitive evidence of cracking due to thermal fatigue. Thermal fatigue refers to crack initiation and growth due to repeated heating and cooling cycles. Thermal fatigue was the result of variable boiler firing and transient periods of excessive heat input combined with poor water chemistry control and excessive water side deposition. Abbreviated results of the failure analysis are shown below:

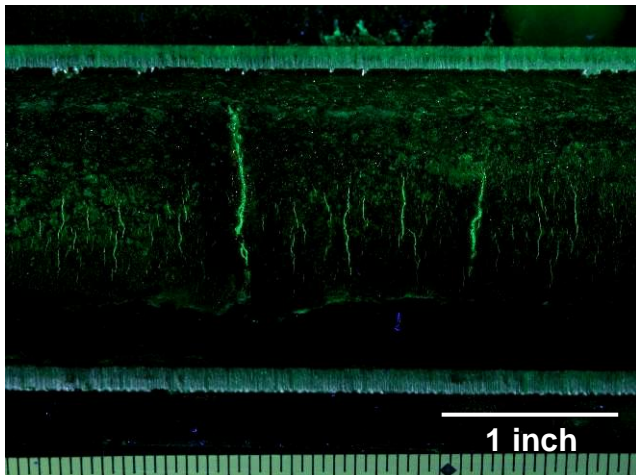
Hot Side

A leaking floor tube was received from a 100,000 lb/hr lumber mill hog fuel boiler. Visual inspection revealed multiple transverse cracks on the top (hot) side of the tube. An absence of crack branching suggests that fracture was not the result of stress corrosion cracking. An absence of deformation adjacent to the cracks suggests that cracking was not the result of a gross single event overload. The circumferential orientation of the cracks is indicative of an axial tensile stress.
