## Analysis of a Leaking Hog Fuel Boiler Floor Tube

Analysis of a leaking boiler tube revealed definitive evidence of cracking due to thermal fatigue. Thermal fatigue refers to crack initiation and growth due to repeated heating and cooling cycles. Thermal fatigue was the result of variable boiler firing and transient periods of excessive heat input combined with poor water chemistry control and excessive water side deposition. Abbreviated results of the failure analysis are shown below:

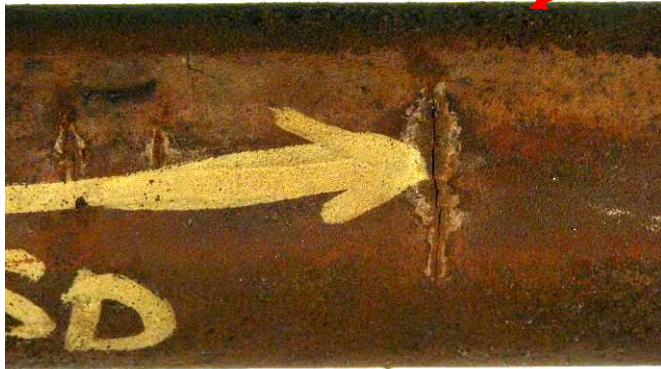
A leaking floor tube was received from a 100,000 lb/hr lumber mill hog fuel boiler. Visual inspection revealed multiple transverse cracks on the top (hot) side of the tube. An absence of crack branching suggests that fracture was not the result of stress corrosion cracking. An absence of deformation adjacent to the cracks suggests that cracking was not the result of a gross single event overload. The circumferential orientation of the cracks is indicative of an axial tensile stress.
